Pioneer Mission Support

This article reports on some recent activities within the Deep Space Network in support of the Pioneer Project's in-flight spacecraft. The amount of tracking coverage provided by the Network and the current status of operational testing of the Mark III Data Subsystems are presented.

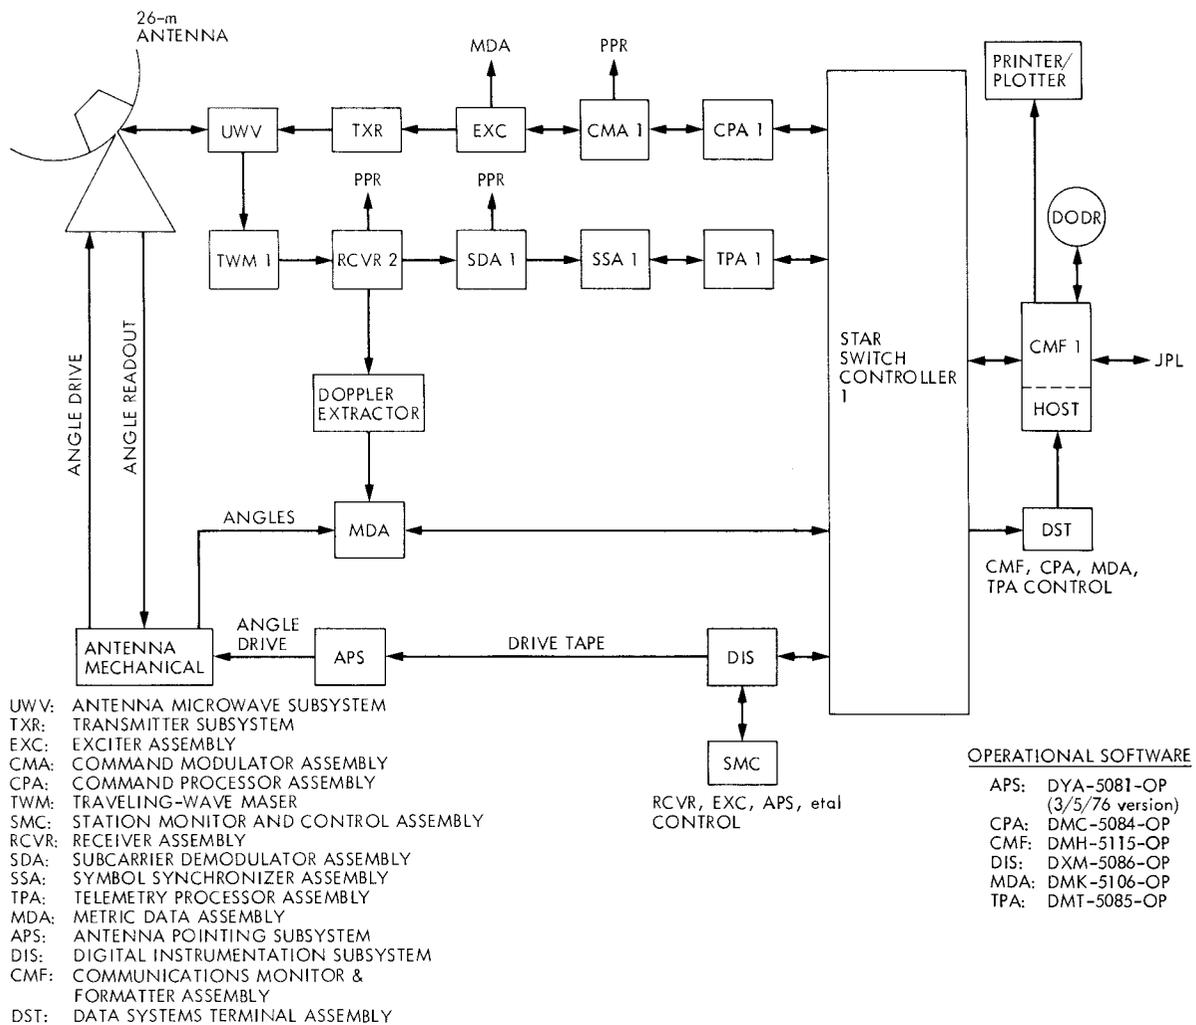
Fig. 1. Standard Pioneer configuration—DSS 12

The pass was structured to closely resemble a typical Pioneer track. Activities included standard downlink and uplink acquisitions, the processing of telemetry at several bit rates and frame lengths, the transmission of commands to the spacecraft, and the generation and transmission of monitor and radio metric data to the Network Operations Control Center (NOCC). The initial station configuration used for the pass is shown in Fig. 1.
